Windstorm Resilient Rural Housing: Lessons learned in Temerloh, Malaysia

Abstract

Keywords: Rural housing; Windstorm; Resilience; Malaysia

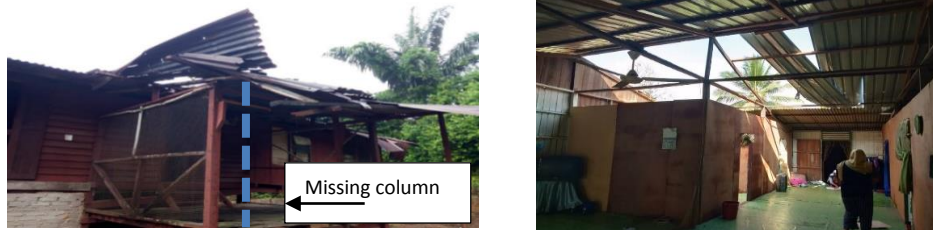
Based on the rapid evaluations, we identified and defined major typical failure modes of all the damaged houses evaluated based on photographic evidence, as shown in Figure 3-4. For each of the typical structural failure modes, we included a sample representative photograph, and a summary of posting (Safe, Restricted Use or Unsafe) and we presented a description of possible causes of failure under each figure.

Fig. 3. (a) Loss of vertical column support and overhang roof damage; Post Restricted Use with barricade the front portion (b) Purlin and rafter section sizes were inadequate and purlin-rafter connection failure and roof blown away) Damaged interior contents due to broken fallen roof sheathings; rain water intrusion; Post Unsafe with falling hazard

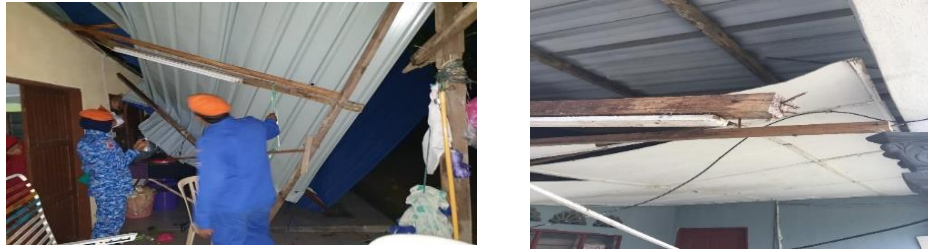
Typically damaged roof sheathings were 0.18mm thick corrugated zinc roof sheets attached by roof nails to timber trusses. Interviews with homeowners showed that thicker sheathings did not replace these thin corrugated during repair and replacement after the windstorm. Wind uplift caused roof sheathings to displace a distance away, but most of the walls remained intact. Based on observations of roo debris, roof nails and sheathings were rusty. Rust decreased nail strength that caused roof sheathings to pull out from the rusted connections.

Fig. 4. (a) Roof sheathing damage due to overturning failure mode at roof edges and absence of cross bracing; Post Restricted Use and barricade the side of the house (b) Weak and rusted nail connections

Based on field surveys and findings from this study, we recommend some structural strengthening that can be adopted to rebuild better windstorm resilient rural housing. Thin roof sheathings need to be replaced by locally manufactured thicker roof sheathings. At least 0.38 mm or more in thickness painted with durable zinc coating to replace the 0.18mm thick corrugated zinc sheets used in older houses (IFCR-SRU, 2017). More substantial and closer roofing screws are the preferred fasteners (diameter = 20 mm) to prevent roof uplift subject to strong winds (IFCR-SRU, 2017). From findings, builders used small, smooth-shank roofing nails. Laboratory work done by Wan Chik (2013) confirmed the findings. For a maximum wind speed of 53.7 km/h in selected study areas in rural Malaysia, screw fasteners resisted much higher pull force than nail fasteners at a spacing of 850mm between purlin and roof sheathings. Cross bracings in rafters and trusses prevent overturning and provide load path for lateral wind loads to the transferred to the foundation. Hipped roofs have a better aerodynamic performance of wind results in lower suction pressure compared to gable and mono-pitched roofs (IFCR-SRU, 2017). More massive overhangs have more substantial wind pressures as seen in some of the damaged roofs.

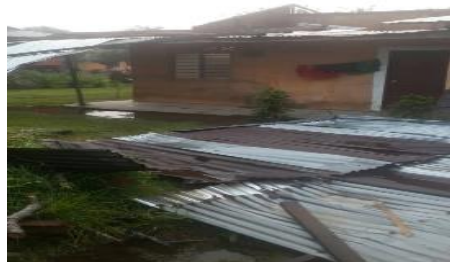
Fig. 7. (a) Roofing damage and transported a distance away due to failure of poor connection and use of lightweight zinc materials creating higher net uplift forces (b) Loss of wall frame due to poor connections between wood and brick wall (Source: Field survey reports by APM)

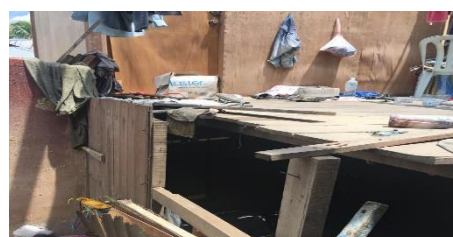
One of the main observation from the field survey was that older building experienced more severe damage compared with newer homes. Figure 8(a) shows an older and newer located in the vicinity of the area, with the older home experienced severe damage. In contrast, the newer building with a newly built roof system did not experience any damage. The older home experienced damage to external facade. The poor conditions of the zinc roof and poor connections could not withstand the higher than average wind speed. Some properties have a second story provide shelter during a strong windstorm and protection from flying debris and fallen trees and branches. The time to start repair work was slow due to lack of workforce.

Fig. 8. (a) Adjacent rural homes with newly built roof with thicker roof sheathings did not experience any damage (b) Wind damage to interior walls and possibilities of damage to vertical support structural system when the roof was breached

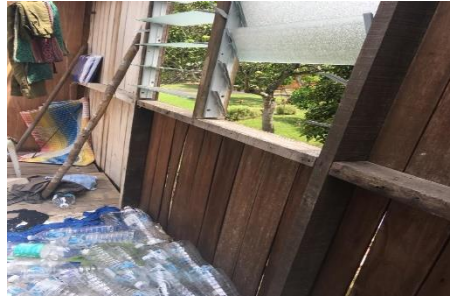
Fig. 9. (a) Damage to windows & (b) Plywood separation from structure

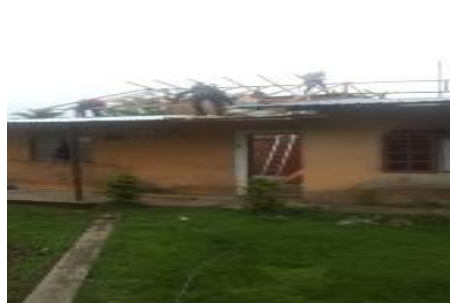
Fig. 10. (a) Repair work undertaken by Malaysian Armed Forces (b) There's no change in material used in house reconstruction
(Source for Fig. 9-12: Field survey photo taken during authors' visit on 30th August 2019)
