Assessing the Safety of Heritage Buildings using CPTED Elements

Shahrul Yani Said, Risca Mering

Faculty of Architecture, Planning and Surveying,
Universiti Teknologi MRA, Shah Alam, Selangor, 40450, Malaysia

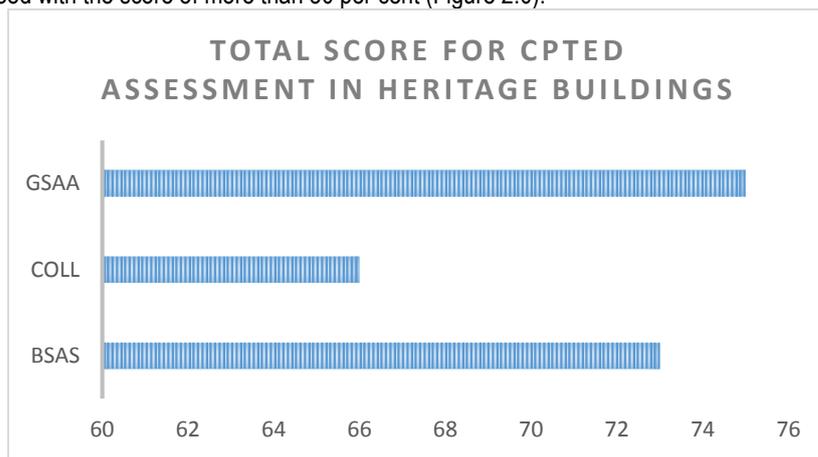
The case study carried out in the three selected buildings shows that the overall effect for safety and crime prevention measure in heritage buildings are good with the score of more than 50 per cent (Figure 2.0).

Fig 2.0 Overall score for safety aspect based on the score sheet

All the buildings, although built post-safety-crime-prevention design approach was equipped with enough counter-surveillance measures that were added later on. The result indicates that GSAA and BSAS, being two historical landmarks scored more than 70% marks on safety based on CPTED criteria. The two buildings are listed heritage buildings and under the protection of the National Heritage Department. Whilst COLL serves as a religious building and privately maintained scored 65%. The distribution of marks for the case studies are as follows.

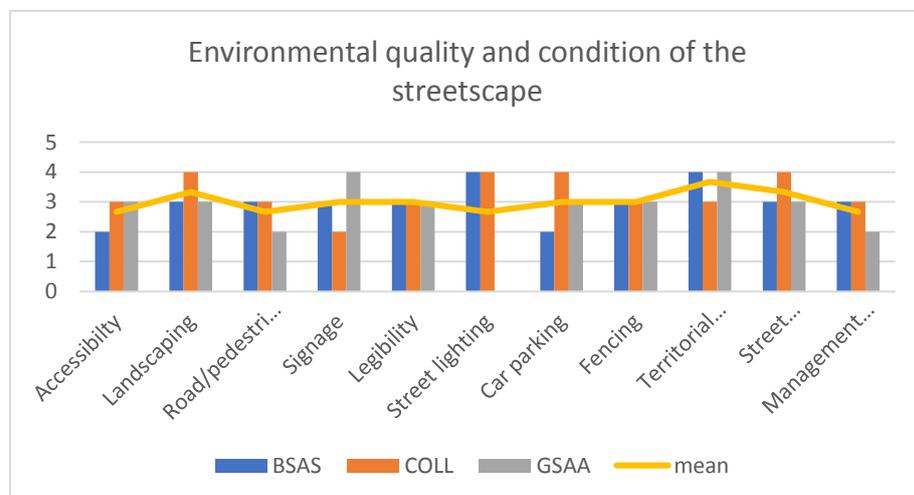
Fig 3.0 The score for the assessment of Environmental Quality/ Condition and Streetscape

CPTED safety assessment carried out indicates that for GSAA, the safety consideration that could be seen physically involving environmental quality and condition of the observed streetscape is at 55% of overall score (Figure 3.0 and 4.0). There was no street

lighting near the building (rating 0) that could contribute to safety issues at night. On the contrary, the gated condition, proper signage, and demarcation of territorial division help to create a conducive safe area. Other variables for environmental quality/condition of the streetscape recorded more than minimum score, which can be concluded that the safety design consideration is there.

BSAS scored 4 for territorial definition and street lighting which also above the mean aggregate. However, the car parking and accessibility to the building are minimal due to the function of the building in which explains the 2 marks scored. The new design for the River of Life project helps to create a passive surveillance system that helps to provide a safe environment for the building naturally.

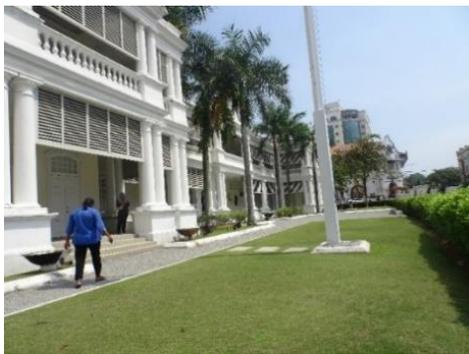
Fig 4.0 Clear territorial definition, trimmed landscape and clear access at GSAA

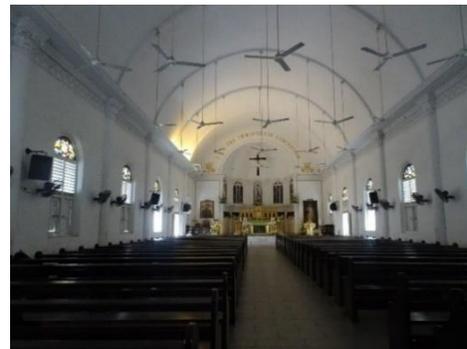
Fig 5.0 Wall with a number of windows provide surveillance from inside the building at CoLL

On the other hand, the Church of Our Lady Lourdes (CoLL) aggregated scores are above the mean score. However, the signage condition is not easily seen and read that resulted in the low score achieved. However, the design of the walls with some windows helps as natural access surveillance (Figure 5.0). This building is easy to access and provided with car parking facilities. The well-designed landscape also contributed to passive monitoring of this place.

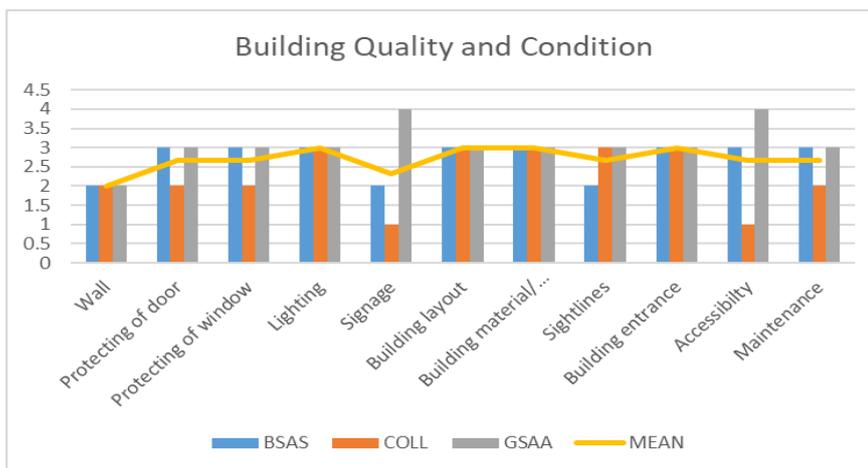
Fig 6.0. The score for the assessment of Building Quality and Condition

Figure 6.0 indicates that many aspects of natural surveillance were taken into consideration in the design of the building. Nonetheless, blind walls surrounding the building prevented natural surveillance and scored only 2 for all case studies. The building has good accessibility between spaces and signage that helps to navigate users. The usage of keycard and passcode on doors restrict the accessibility to some private areas whilst several large windows provide natural surveillance from inside the building.

GSAA scored the 3 points and above for every CPTED elements in the building and is considered having the best accessibility and signage among the three buildings with the full score, higher than the mean score for both categories. The signage in this building helps to navigate people from one space to another, and the exit and entrance sign is visible to assist in guiding people. GSAA was built as a

The building quality and condition of BSAS, on the other hand, has a nearly perfect score of 3 points for every element except for a lower score for the blind wall, signage, and sightlines. BSAS is a majestic, iconic landmark of Kuala Lumpur. It has large and tall columns and many blind spot corners that can be some severe impediments to the feeling of being safe. The design provides poor sightlines for safety consideration of the building. Besides that, most of the envelope walls are blind walls that prevent direct outside view. The signage is present but poorly done that it is not easily spotted and read from far; thus the low score achieved.

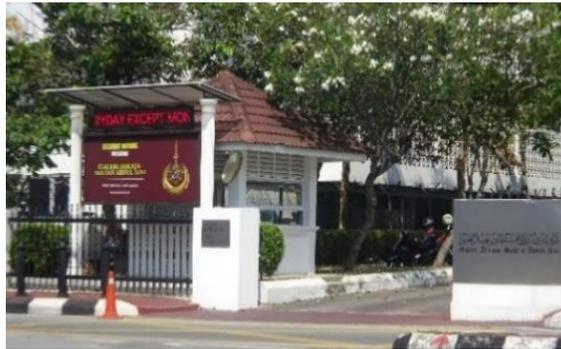
government building and it is designed to be accessible for the public, hence the perfect score. As an essential building, GSAA is well gated and guarded (Figure 6.0)

Fig 7.0 Gated and guarded facility (GSAA)

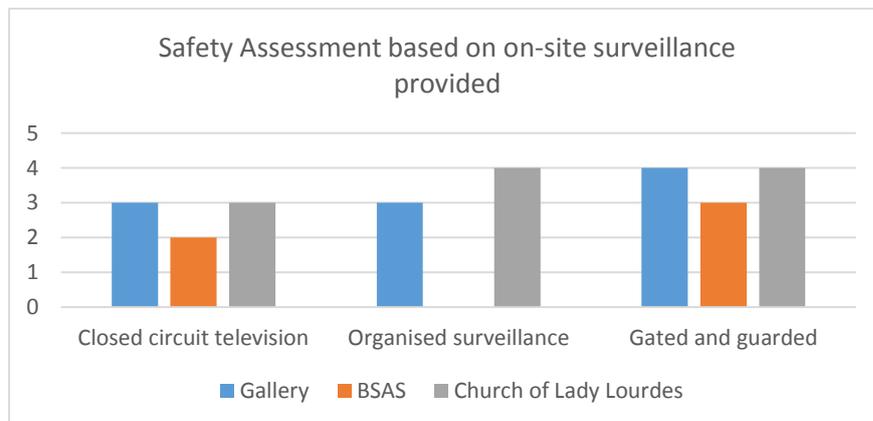
Nonetheless, the safety of this building mostly depends on its added on-site surveillance devices. The assessment pointed out that GSAS and COLL are fully equipped with an on-site surveillance system. Both buildings are gated and guarded by security officers. CCTVs were installed at most of the corners and blind spot areas. BSAS has no organized surveillance system, although equipped with CCTV and guarded. This well-known landmark is designed and prepared for visitors who mostly are tourists. Heavily imposed security system, on the other hand, will create some tension for them. Thus, this building depends on natural surveillance to ensure its safety

Fig 8.0.: The score for on-site surveillances provided for the buildings
