Enhancing the heritage conservation by Sustaining Historical Buildings: Hail Palace, as a case study

4.1 The current situation of the case study King Abdul-Aziz Palace in Hail (Observation)

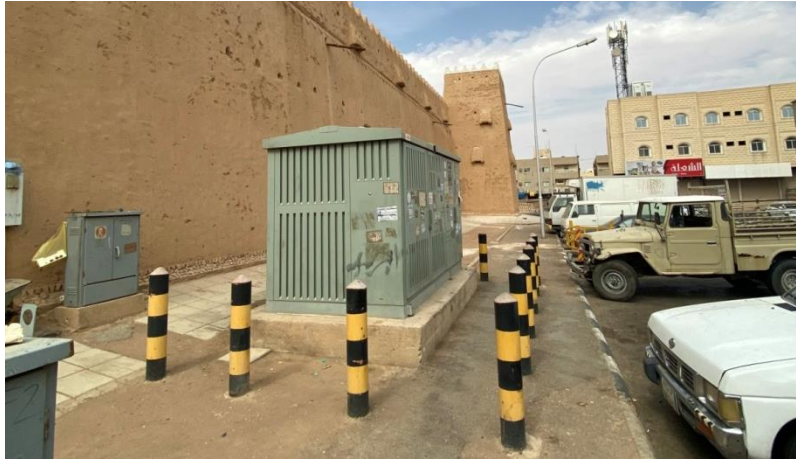
Photo4.2 the visual distortions contrasting with the building and its historical and aesthetic value
(Source: author)

Al Qieshlah palace is situated in the middle of Hail city see photo 4.1. From the observation and the site visit to the case study area, it becomes clear that the Al Qieshlah was a significant historical building that is considered one of the most prominent landmarks in Hail city, the palace surrounded by commercial streets, modern facilities, and markets from all directions, all these effects contributed to giving an image and visual distortions contrasting with the structure and its historical and aesthetic value. It can be deduced that palace's surrounding area is suffering from a loss of archaeological significance, as the area surrounding was treated separately from the historic building. As shown in the photo 4.2

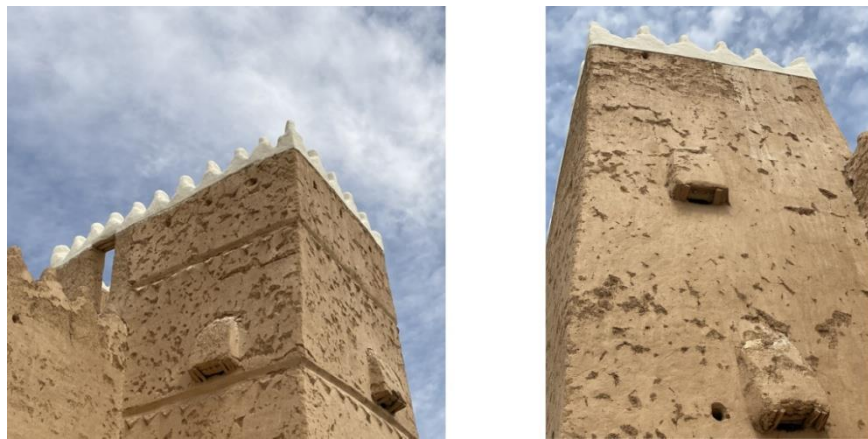
architectural display. These decorations are carried the fully expressing the aspects, and the architectural style of Najd region. Most of the decorations on the exterior walls and the towers are in poor condition. Photo 4.3 illustrates the poor condition of the decoration on the towers of the building.

Photo4.3 poor condition of the decoration on the tower.
(Source: author)

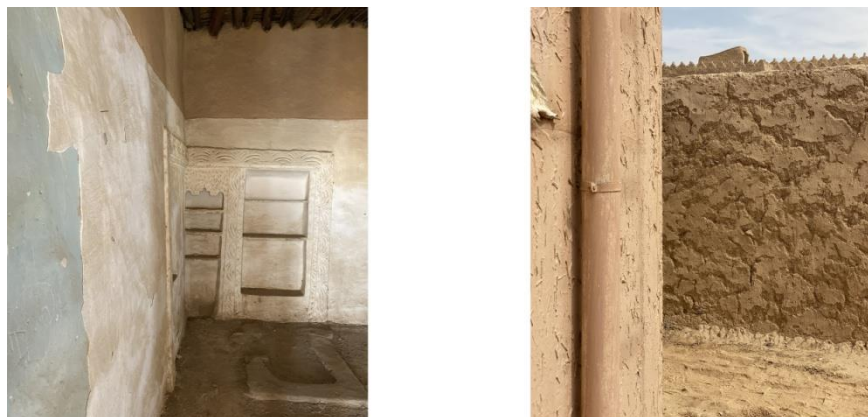
3. The palace is designed around a central courtyard, surrounded by military barracks (rooms) stand with two floors, The courtyard is surrounded by a covered corridor that precedes the military barracks(rooms), grounded on a round colonnade. Most of these military barracks(rooms) were built of clay and in good condition. In contrast, some of them on the ground floor are in lousy condition as shown in photo 4.4. A clay wall is separating the courtyard stretched from east to west, and another separates this wall from the north to the south of it in a bad condition also as shown in photo 4.5, those two walls have been added during the police work.

Photo 4.4& 4.5 lousy conditions of the mud walls
(Source: author)

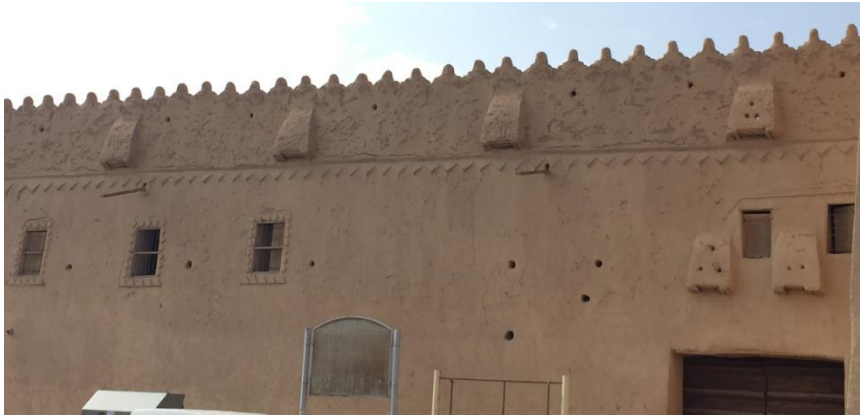
The palace was built on the traditional method using local materials, the materials used in construction are found to be locally available and mostly raw materials that are, where clay was used for walls and finishing works, while the stone used for foundations, palm leaves for ceilings, and timber used for doors and windows. Furthermore, it was discovered that the walls approximately are 9.5 m high, and the overall wall thickness is between 60 to 100 centimetres. When looking at these external walls, a variety of decorations are set in a magnificent architectural display. Also, these walls characterized by an abundance of defensive architectural elements, such as Al-Mazaghal is a defensive element, consisting of longitudinal cracks that spread along the walls, and Al-Tarma: It is a small building in the shape of a cone, and at the bottom, there are openings above the door to see who is standing with it from the outside. See photo 4.6. Rounded columns made of stone with two types of base used in the structures; the construction technique of the palace follows the architectural style of the Najd region.

Photo 4.6 Defensive elements and decorations on the palace walls.
