Windstorm Resilient Rural Housing: Lessons learned in Temerloh, Malaysia

Abstract

Keywords: Rural housing; Windstorm; Resilience; Malaysia

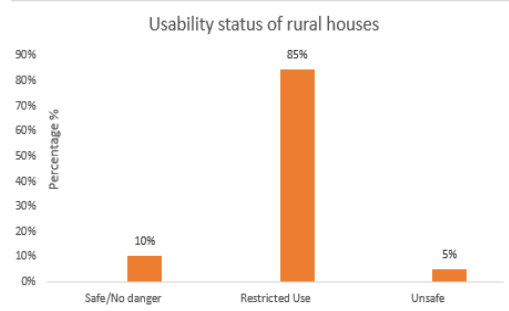
Fig. 2. Usability status of rural houses

We present the results of the status of usability of the buildings using rapid evaluations as shown in Figure 2. According to Figure 2, 10% of the inspected buildings were safe for occupancy. Approximately 85% of the houses that requires restrictions placed on areas of the buildings that were not usable. 5% of the houses were unsafe, and the residents seek shelter temporarily at their neighbours and relatives homes. There was no major collapse. Based on the district-level post-windstorm incident reports and damage pictures, the primary identified causes of damage throughout the community were wind effect. A small percentage of the reported buildings suffered damage due to flying debris from neighbouring roof materials and toppled trees.

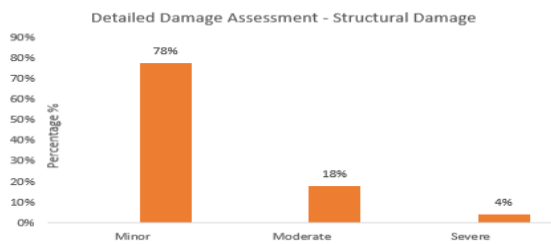
We summarised the results of the detailed evaluation in Table 2. Figure 5 and 6 show the results of the detailed evaluation of statistical patterns in percentage values in terms of the severity of structural and non-structural damages. Damage to structural parts includes column vertical and lateral load-bearing components such as columns, beams, load-bearing walls, roof and floor framing and their connections. Non-structural components consist of ceilings, roof sheathings/shingles and connections, fallen/leaning trees, walls and window. Figure 7 illustrates that 78% of the houses experienced minor structural damage, whereas 18% experienced moderate and 4% severe structural damage. We found that most minor structural damages occurred in the roof system and connections where homeowners need to replace several timber roof beams and purlins. Figure 8 showed that 27% of the houses experienced minor non-structural damage, 62% experienced moderate non-structural damage, and 11% experienced severe non-structural damage.

Fig. 5. Detailed assessment and statistical patterns in terms of severity of structural damage

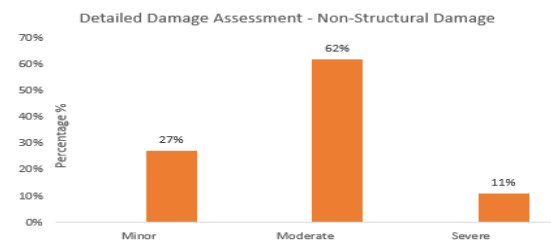
Fig. 6. Detailed assessment and statistical patterns in terms of severity of non-structural damage
